***Hi-Impact 8000 brand Fire-shield
Gypsum Wallboard
5/8" Tapered Edge Type X Core***

***Test #2
Fire inside the wall***

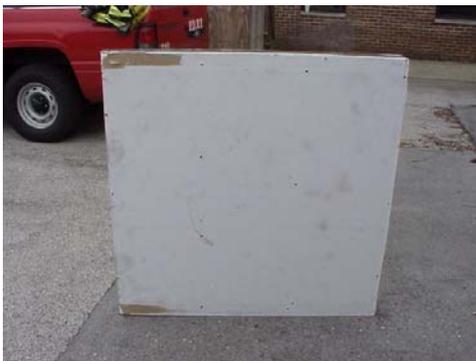
4' x 4' wall with metal stud framing and Hi-Impact 8000 wallboard mounted to both sides of the wall.

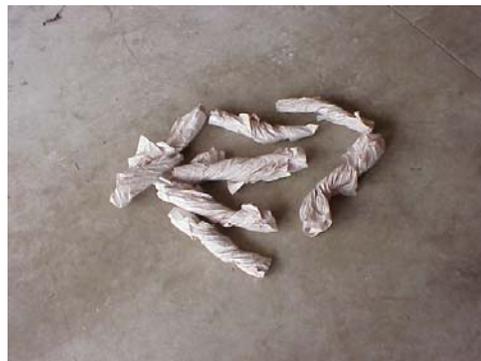
Approximately 4 pieces of white packing paper were ignited inside the wall to simulate burning materials that have dropped into the wall during a structure fire.

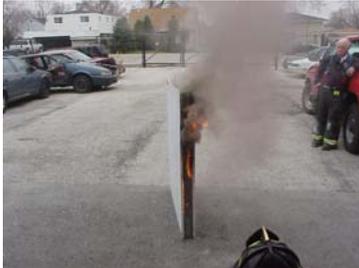
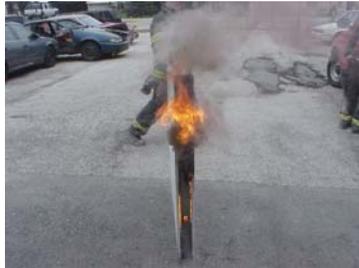
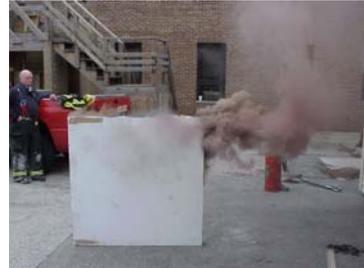
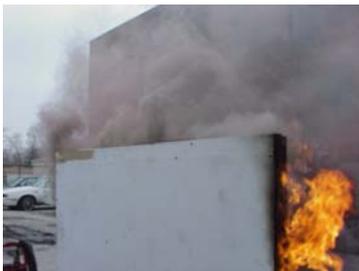
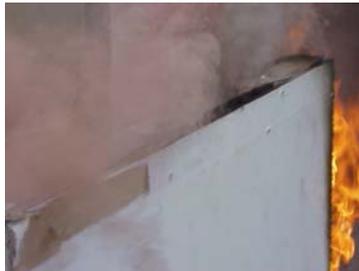
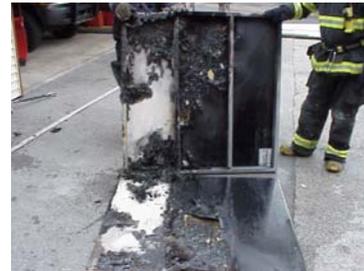
Additional Photos:

After extinguishment, one side of the test wall was removed to evaluate the amount of fire spread inside the wall. The fire completely consumed 1 full bay of the Lexan backing between the stud spaces where the fire was started. The fire then traveled through the pipe chases in the stud to the next bay, consuming the top ½ of the 2nd stud space. It was noted that some of the Lexan that had melted down was starting to ignite the bottom of the wall in the 2nd stud space. The 3rd bay in the test wall suffered very minor damage if any at all.

In conclusion, it was demonstrated that the Lexan backing contributed to the fire spread within the wall. The Lexan backing also created a heavy and multiple colored smoke condition during the burn phase of the test.
